Exploration Drilling >> SAFETY ACCESS TUNNEL

Breaking new ground!

Exploratory drilling for a safety gallery to serve an existing motorway tunnel in Switzerland

Injection and drilling work for a pressure shaft and hydropower plant

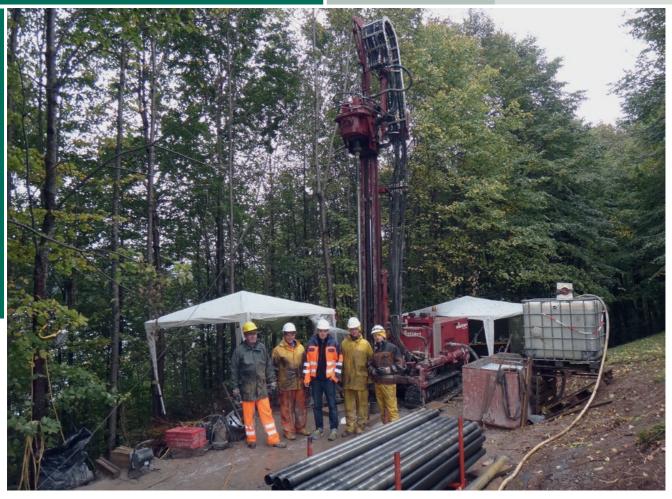
Drilling site for the 300 m-deep exploration hole in difficult terrain

The deeper holes (down to 300 m) were begun as destructive drillings and switched over to wire-line core barrels at 150 m depth. Drilling accuracy was a very high priority and it was essential to survey the holes by gyroscope probe on a continuous basis in order to keep the hole on its specified path. Gas measurements for methane and carbon dioxide (CH_4, CO_2) were also carried out and digitally logged throughout the drilling operation.

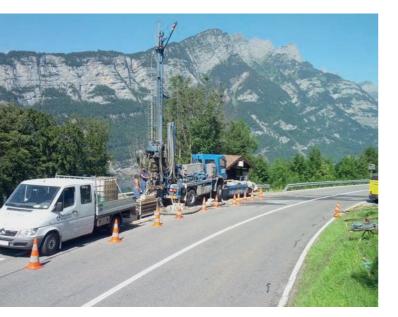
Drilling on a motorway access road

The exploratory drilling along the motorway was undertaken with the road only partially closed and the traffic flow was impeded to a minimal degree with some lanes closed off for certain periods. By removing the crash barriers and taking down the noise-insulation panels the most inaccessible drilling points could easily be reached by mobile crane.

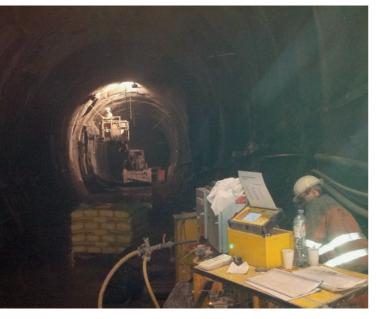
Injection and drilling work for a pressure shaft and hydropower plant

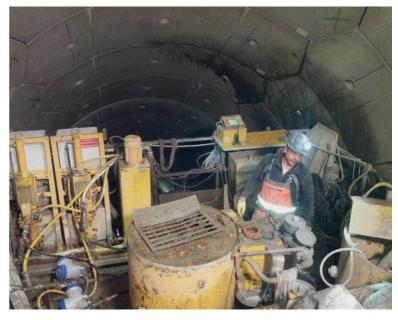
Grouting material being injected through the concrete tubbings in the inclined shaft

between the strata and the shotcrete lining or tubbing support ensures that the rock maintains its load-bearing capacity when subjected to internal water pressure. After the main excavation work had been completed the strata around the pressure shaft was reinforced via borehole injections carried out through the openings in the tubbing. This rock injection process was undertaken at a maximum injection pressure of 20 bar.
